Flight Helmet Cords Can Impede Egress

■ Understand the hazard of direct-to-airframe cord connections

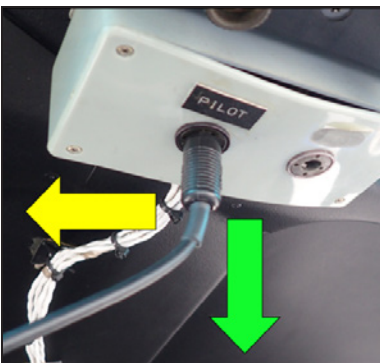
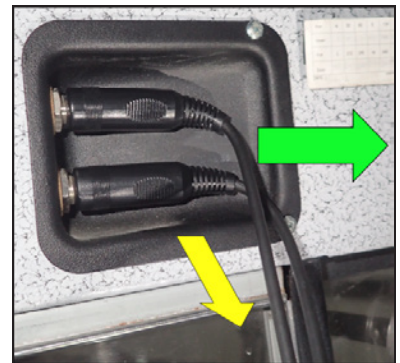
- In the event of an accident or emergency in which an aircraft occupant wearing a flight helmet needs to egress quickly (such as a ditching, water impact, or fire), fast and unimpeded egress from the aircraft is essential for survival. **Direct-to-airframe intercommunication system (ICS) cord connections between the flight helmet and the airframe can impede egress during an accident or emergency.**¹
- **The cord connecting the flight helmet to the aircraft's ICS might not release readily from the airframe ICS port if the direction of egress is contrary to the direction needed to easily release the cord** (see figures 1a and 1b). For instance, if a cord needs to be pulled downward for release and an aircraft occupant is attempting a sideward egress, the cord may not release readily, which could cause excess delays in egress.

Figures 1a and 1b. Airbus (formerly Eurocopter) AS-350 B2 (left) and Piper PA-18-150 (right) pilot-seat airframe ICS ports. The green arrows show the direction needed to easily release the ICS cords, and the yellow arrows show the direction of occupant egress.

- **Ensure that you and your passengers understand and are proficient with the egress procedures for the aircraft that you are operating before you take off.**
- **Use a compatible intermediate cord between the ICS cord and the airframe ICS port to facilitate a clean separation during egress. The intermediate cord is a cord connecting to the airframe ICS port on one end and to the ICS cord on the other end, allowing the ICS cord to be disconnected in the direction of egress.**
- **Ensure that ICS cords are secured from potential snagging or entanglement with components such as flight controls.**

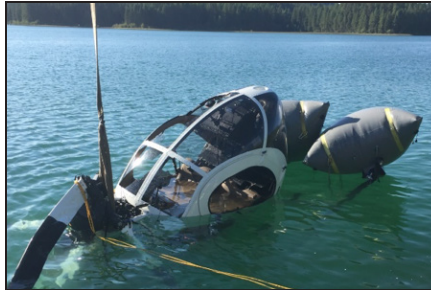
- **The pilot of an MD Helicopters (formerly Hughes) MD-369E lost control while filling a water bucket at night over a lake** (see figures 2 and 3). After the helicopter impacted the water, inverted, and started sinking, the pilot pulled himself out of the cockpit. **He reported that, as he came out of the cockpit underwater, he felt his flight helmet tug backwards; the ICS cord was still attached to the airframe ICS port.**

Figure 2. Helicopter in water.

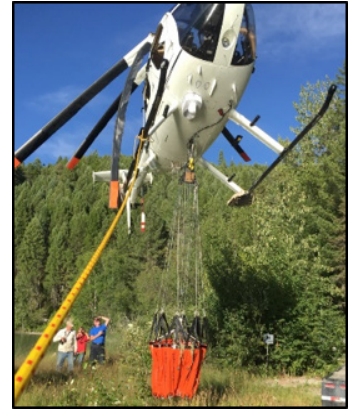
Figure 3. Recovered helicopter.

The pilot removed his flight helmet, surfaced, and swam to the shore without further incident; he sustained minor injuries. ([GAA15LA217](#))

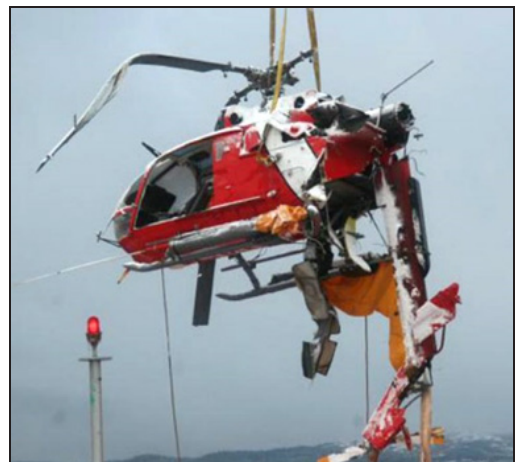
- **An Airbus Helicopters (formerly Messerschmitt-Bölkow-Blohm) MBB BO105 impacted water while flying at low altitude over a bay in snow and darkening conditions in Canada** (see figure 4). The helicopter sank, and the pilot and passenger were able to egress from the helicopter. After the egress, the pilot died from hypothermia, and the passenger drowned. **A postaccident examination of the pilot's flight helmet revealed that the end fitting of the ICS cord was fractured where it attached to the port. Metal remnants showed that the cord was being pulled sideways toward the pilot's door (as opposed to downward for release) when the fracture occurred;** a postaccident test of a similar fitting required a 70-lb pull before the cord failed. (TSB Report [A05A0155](#))

Figure 4. Recovered helicopter.

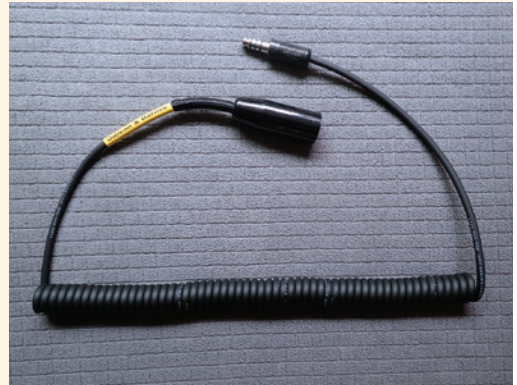
Figure 5. Exemplar intermediate cord.
