Yorkton Aircraft Service Young Pilots Session February 2015

Engine Operation Limits and Performance

PT6A Pilot Familiarization

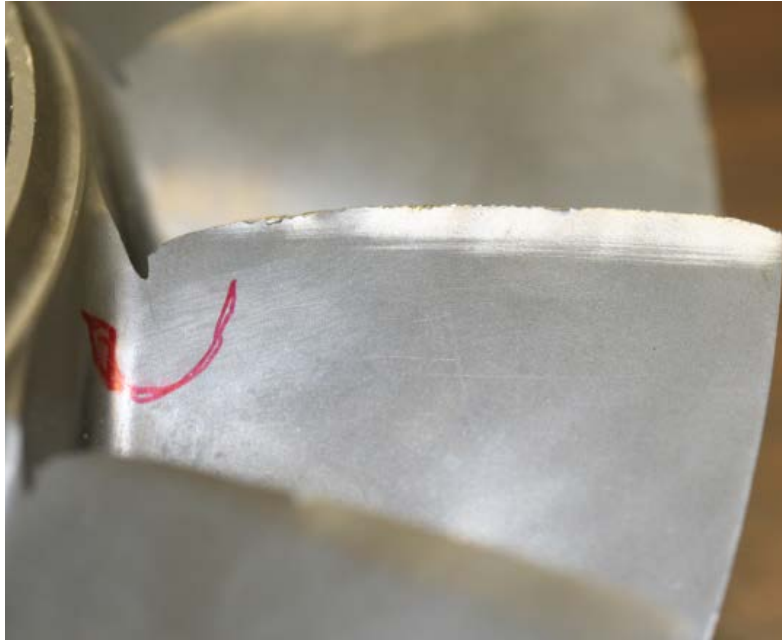
Compressor Rotor Maintenance

What cause the observed damage?

Erosion due to sand / dirt ingested

- ✓ *Inspect Air Inlet Filter per the OEM recommendations*
- ✓ *Compressor recovery wash*
- ✓ *Inspect the bleed valve closing point*
- ✓ *Report unusual noise (humming, hooting)*

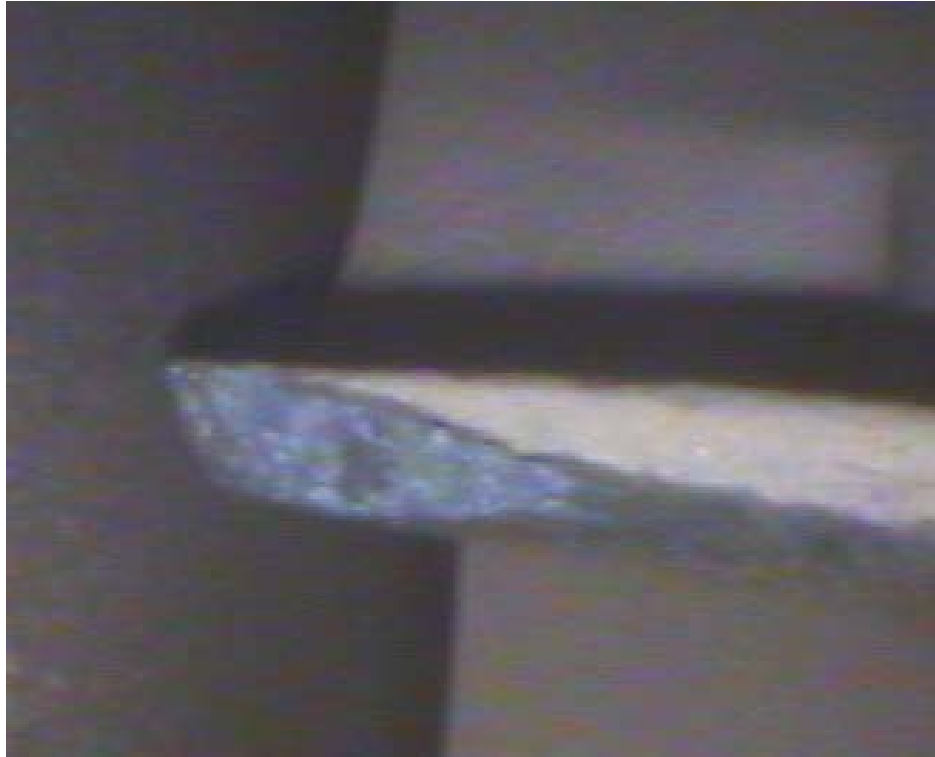
CT Blade Damage noticed during Borescope Inspection

- CT Blade light erosion
- Carbon erosion
- No performance deterioration

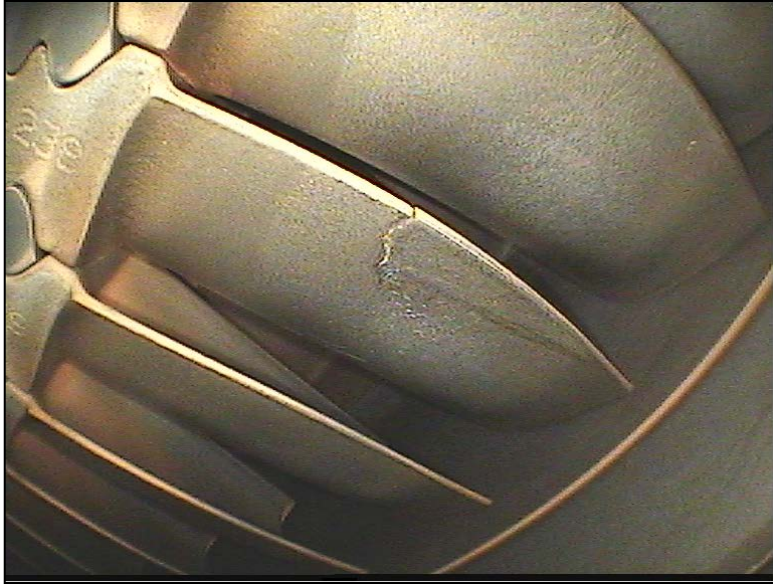
Creep = to time, temperature and rotational stress.

- Tensile overload fracture can only occur after solutioning (excessive heat).
- Results of a visual examination revealed **necking** near the fracture surface
- Cross section along blade axis approximately revealed **microvoids** at grain boundaries.
- Higher magnification shows microvoids along with **coarsening and partial solutioning of the gamma prime precipitates**

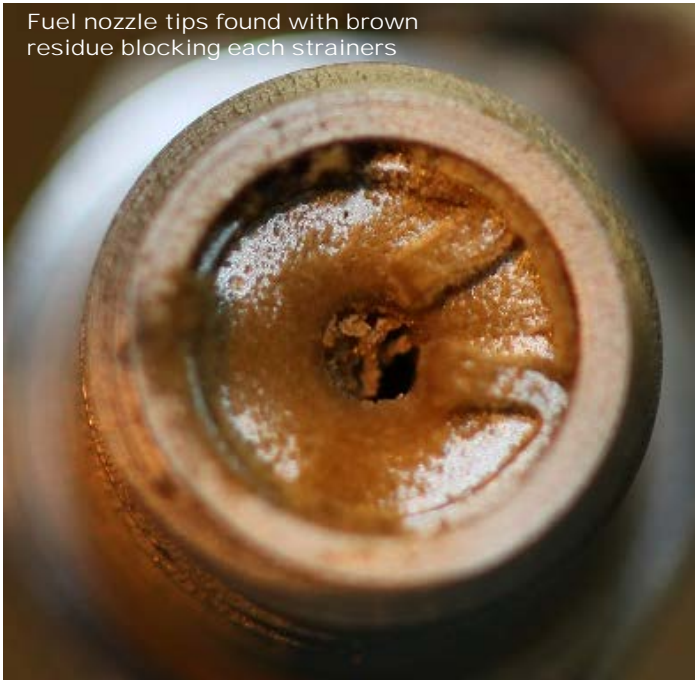
Fuel nozzle tips found with brown residue blocking each strainers

Fuel nozzles found some brown residue blocking each strainers

Two of them did not flow at all on flow bench, the rest flowed badly, some streaking

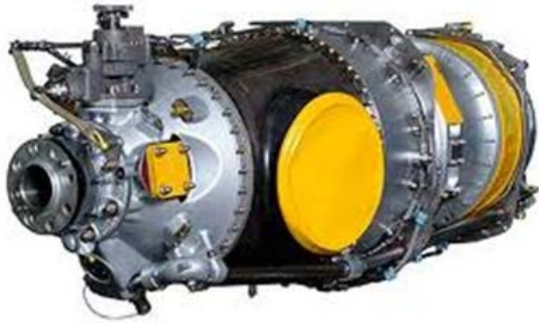
Operator landed, refueled and loaded fertilizer, during take-off the engine flamed out.

Subsequent inspection revealed 100% liquid fertilizer in the fuel system.

The fuel loading tanks had been inadvertently filled with fertilizer
